SUNFLOWER POWER CONVERSION SYSTEM

QUARTERLY REPORT

SEPTEMBER - NOVEMBER 1962

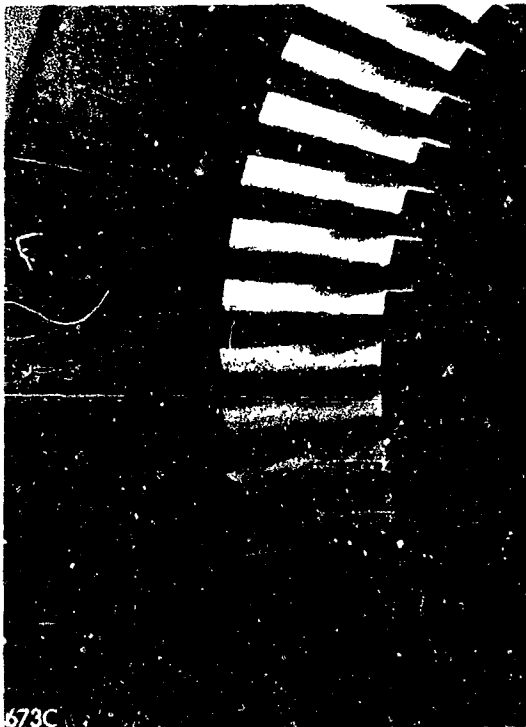
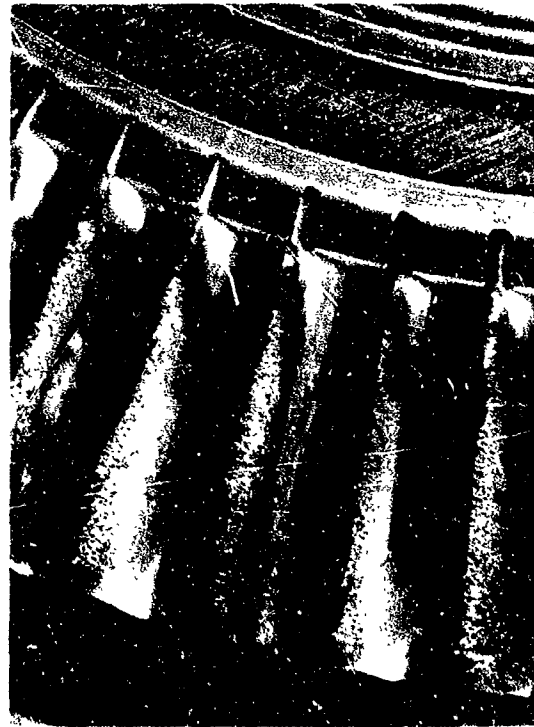
FIGURE 4

The disassembly of CSU 1-3 was continued throughout the quarter. As reported in the previous quarterly progress report, the corrosion product formation build up on the first stage nozzle occurred until the deposited materials were of sufficient size to cause rubbing of the first stage wheel and ultimate failure of the unit. Further inspection has shown other areas where minor corrosion product formation has occurred. These include the second-stage nozzle in the throat areas, and the first and second stage wheels in the blading. In addition to corrosion product formation, some erosion was noted on the pump impeller, on the outside diameter of the alternator rotor where it probably contacted liquid mercury and on the second and third stage turbine wheels which show damage on the leading edge of the wheels. The more severe erosion on the leading edge of the third stage wheel is indicative of the mismatched velocity profiles which occurred from the off-design area of the third stage nozzle. This damage is illustrated in Figure 4.

The erosion damage which occurred in the pump impeller has been attributed to the clogging of the jet pump nozzle which occurred throughout the majority of the 2300 hour test. With the nozzle being restricted, the jet centrifugal pump was caused to operate in a cavitation region and therefore the cavitation damage noted on the eye of the impeller is not to be completely unexpected. Post-test component runs of the pump impeller indicate that the

EROSION DAMAGE NOTED DURING 2300 HOUR CSU I-3 TEST

CSU I-3 Mercury Pump Impeller

CSU I-3 Alternator Rotor

CSU I-3 Second Stage Wheel Entrance

CSU I-3 Third Stage Wheel Entrance

erosion damage on the impeller has not affected performance of the pump and simulated runs with the jet nozzle supply shut have shown data comparable to that obtained during the CSU I-3 test.

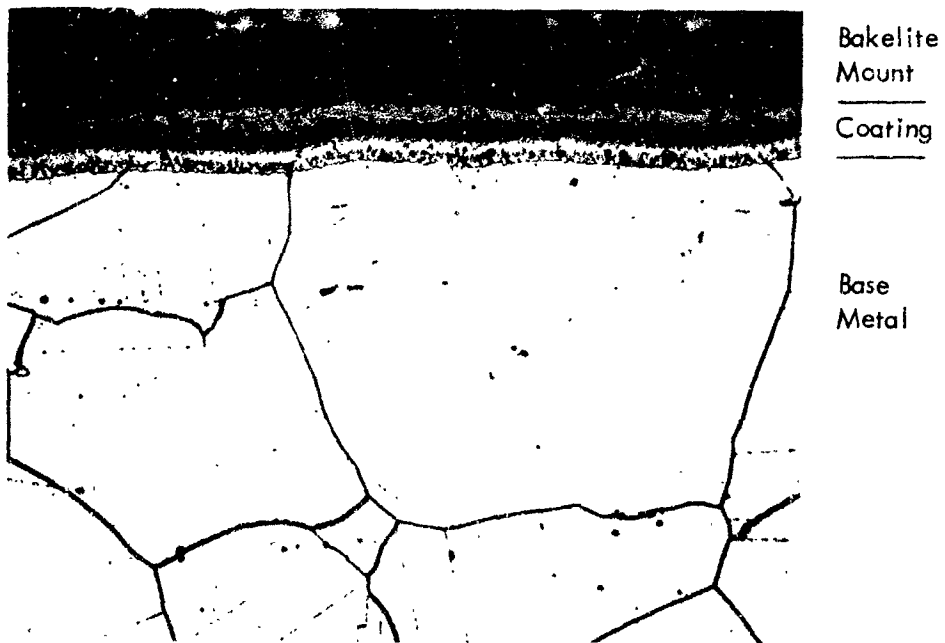
RDM 6012

SILICON-COATED HAYNES 25 BEFORE PERMEABILITY TESTING,
500X, REFRACTORY METAL ETCH

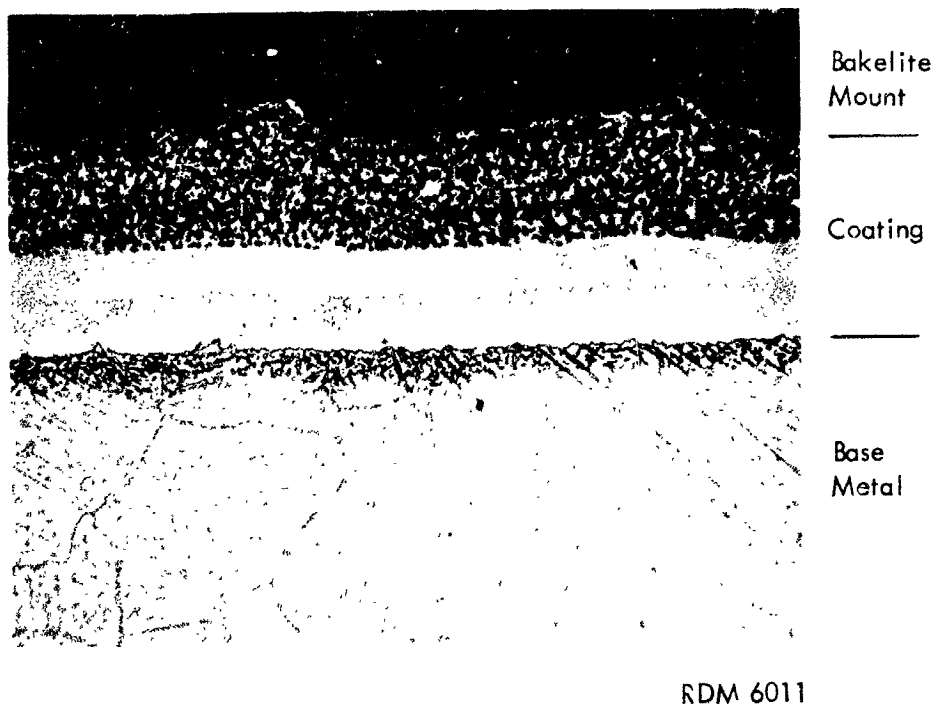
After the completion of the permeability tests (approximately 250 hours) the appearance of the coating was significantly altered (see Figure 7). X-ray diffraction of the coating subsequent to testing showed that the CoSi₂ and CoSi type intermetallics were not present and the coating surface consisted primarily of the lower silicon Co₂Si type intermetallic. Although the gross diffusion of the silicon into the base metal is believed to be the primary cause of the coating deterioration, the reason why certain intermetallics (e.g. high silicon intermetallics) are more effective barriers to hydrogen diffusion than those containing lower silicon contents is still a fundamental question which requires additional study.

SILICON-COATED HAYNES 25 AFTER PERMEABILITY TESTING,
500X, REFRACTORY METAL ETCH
